Analysis of the Effect of Impact Damage on the Repairability of Composite Panels

Abstract.

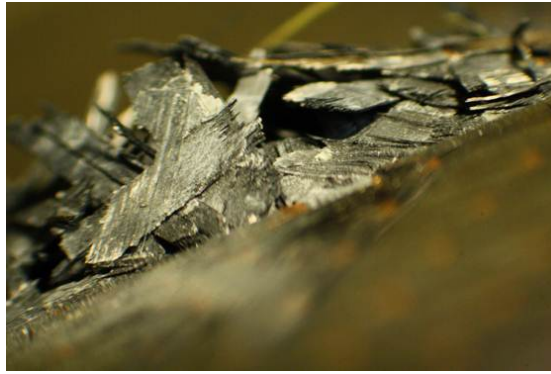
Fig. 5. Micrograph of impact failure of 7 layered CFRP woven compost panel impacted at 141 J (200 m/s).

Fig. 5 presents a micrograph of the impact failure of the 7 layered CFRP woven composite panel impacted at 141 J (200 m/s). This image shows the plies relaxing and closing up after impact by a steel sphere projectile. The tensile and compressive failure in petalling formation can be clearly observed.
